## Colliers charnières PPFV

# Collier de réparation ITEM 141

## ITEM 141 | Collier de réparation

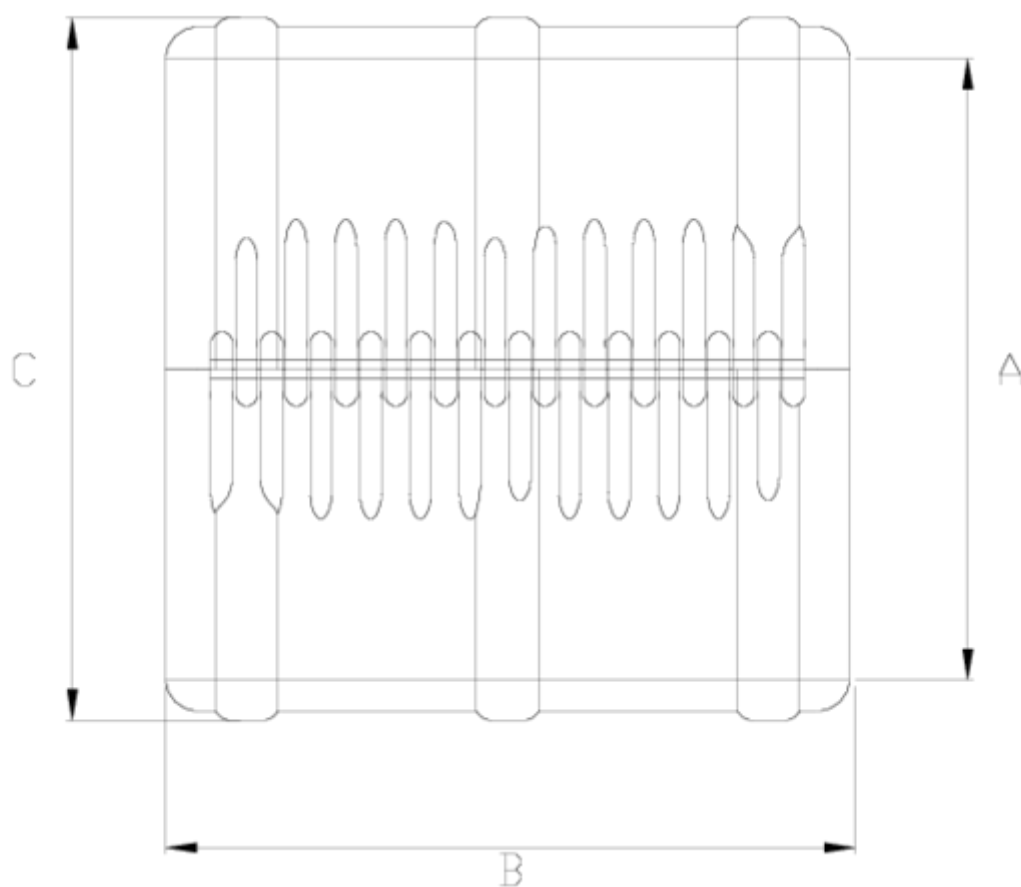
| CÓDIGO | f tubo | PESOS | A | B | C | PN | MEDIDA |
| 05055 | 160 | 2535 | 160 | 225 | 186 | PN6 | MÉTRICO |
| 05053 | 200 | 2484 | 200 | 227 | 226 | PN6 | MÉTRICO |
| 05050 | 225 | 2717 | 225 | 225 | 250 | PN6 | MÉTRICO |
| 05051 | 250 | 3096 | 250 | 239 | 276 | PN6 | MÉTRICO |
| 05052 | 315 | 4398 | 315 | 250 | 344 | PN6 | MÉTRICO |
| 05054 | 400 | 6125 | 400 | 282 | 430 | PN6 | MÉTRICO |
